Limited Visual Dam Safety Inspection Summary Report

MA-086

HC&S Reservoir 81

Limited Visual Dam Safety Inspection Conducted on: 04 April 2006

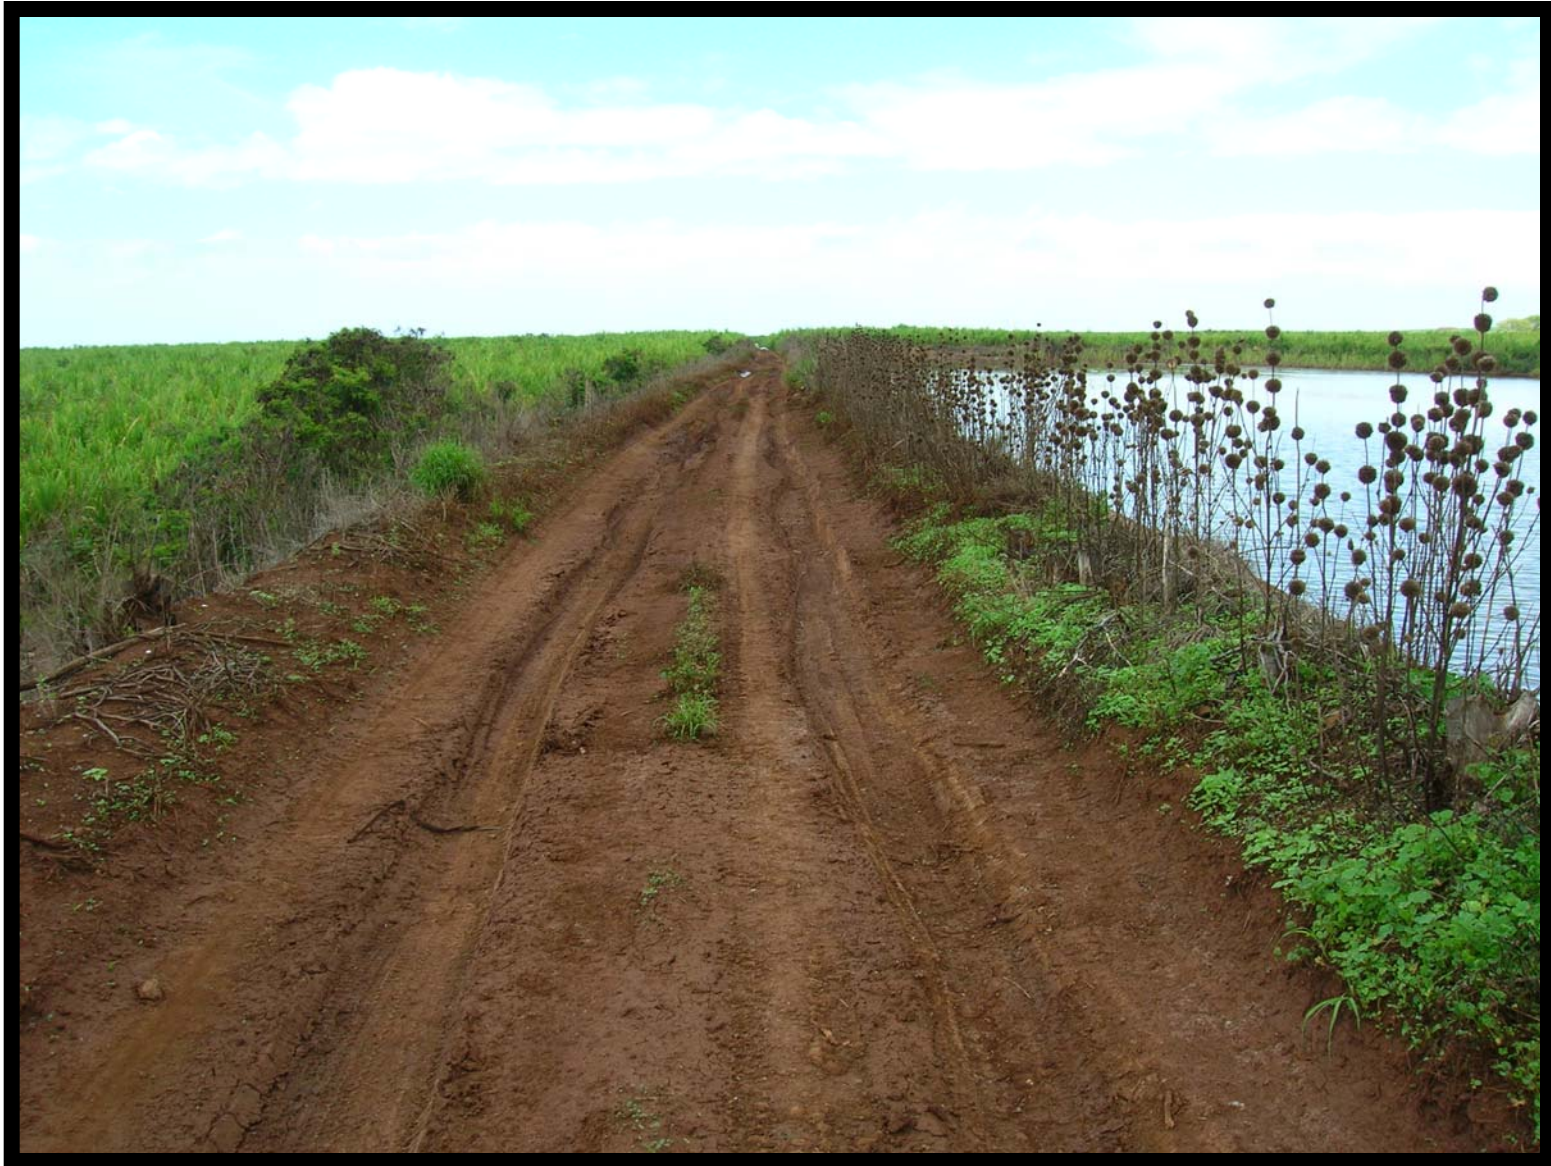
086 crest

Cracks and erosion were not observed. Sinkholes were not observed.

- a. The dam crest appeared to be in satisfactory condition and requires no corrective action.

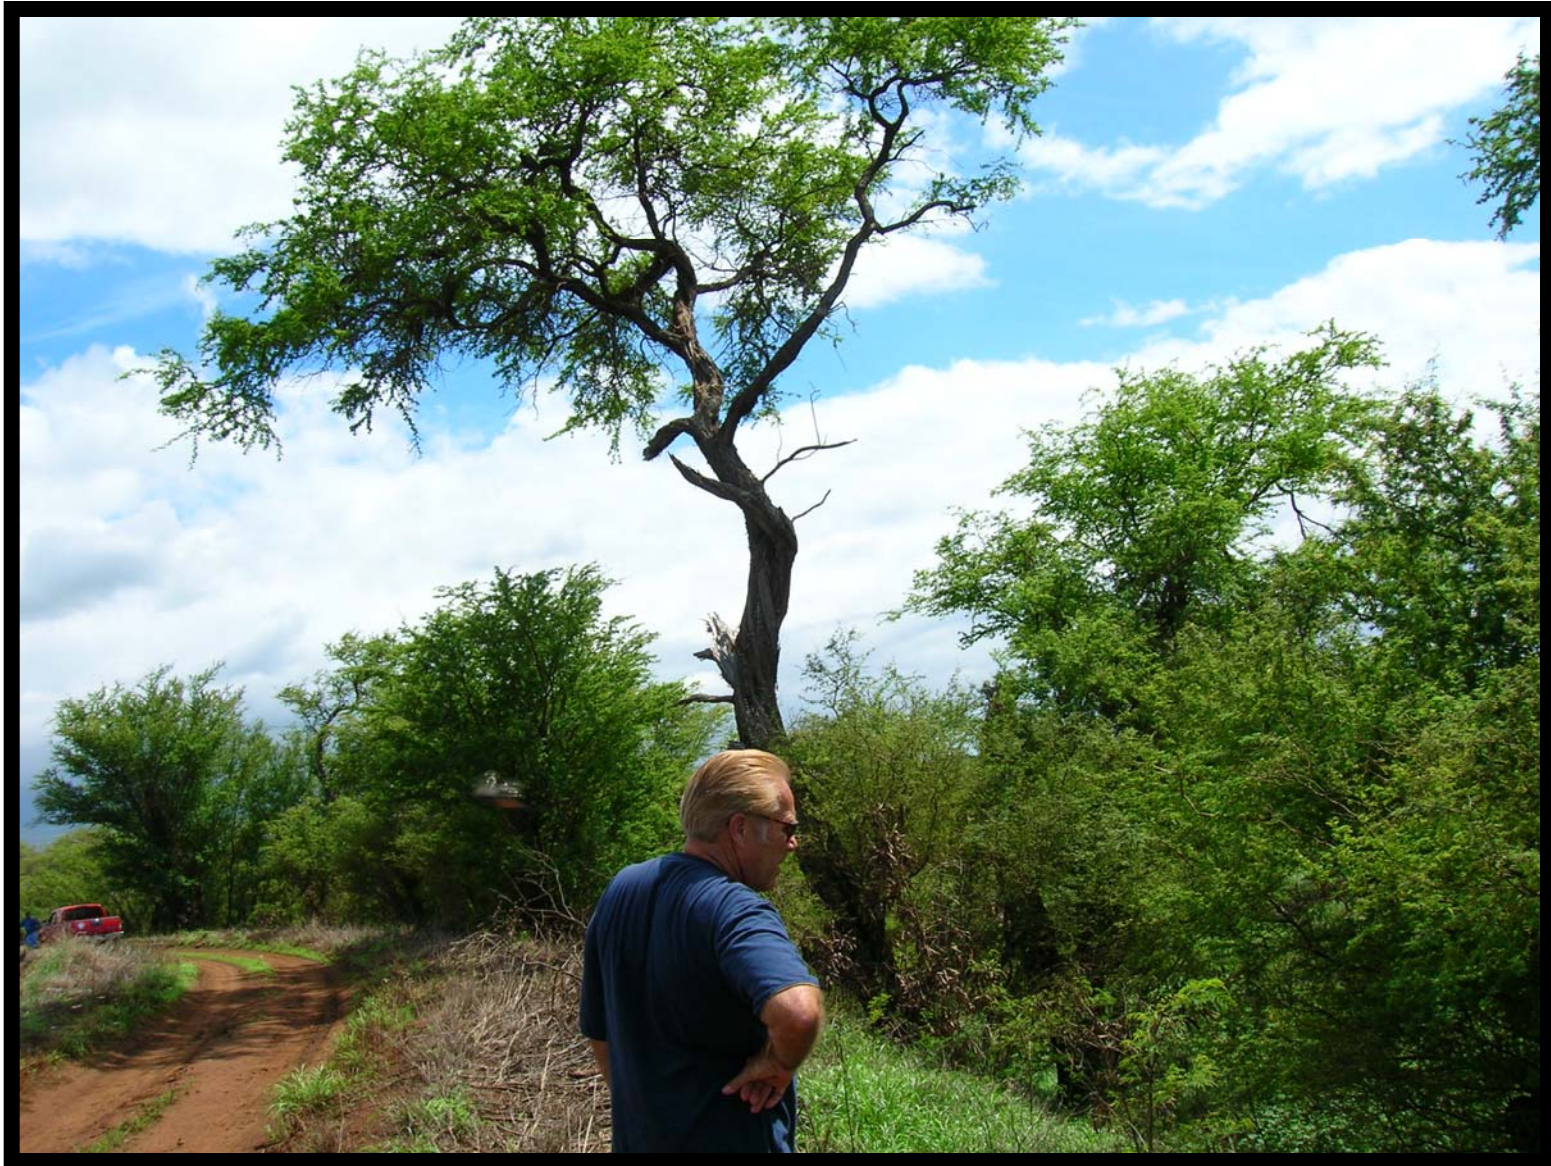
- c. Tree(s) were observed on the downstream slope. Trees have been identified as the probably cause of piping failures, and can possibly cause sever damage to the embankment if they are uprooted during a high winds. Corrective action is required to remove the tree hazards from the dam. Acceptable remedies include removal of the tree and its root structure down to a 2" diameter and reconstructing the damaged embankment section. All repair work shall be accomplished as per the requirements of licensed geotechnical or structural engineer. Routinely monitor the damaged area for signs of settlement and seepage.
- d. The slope was very steep, around a 1 to 1 slope; further study is required to verify slope stability.

086 crest 2 - large tree in slope

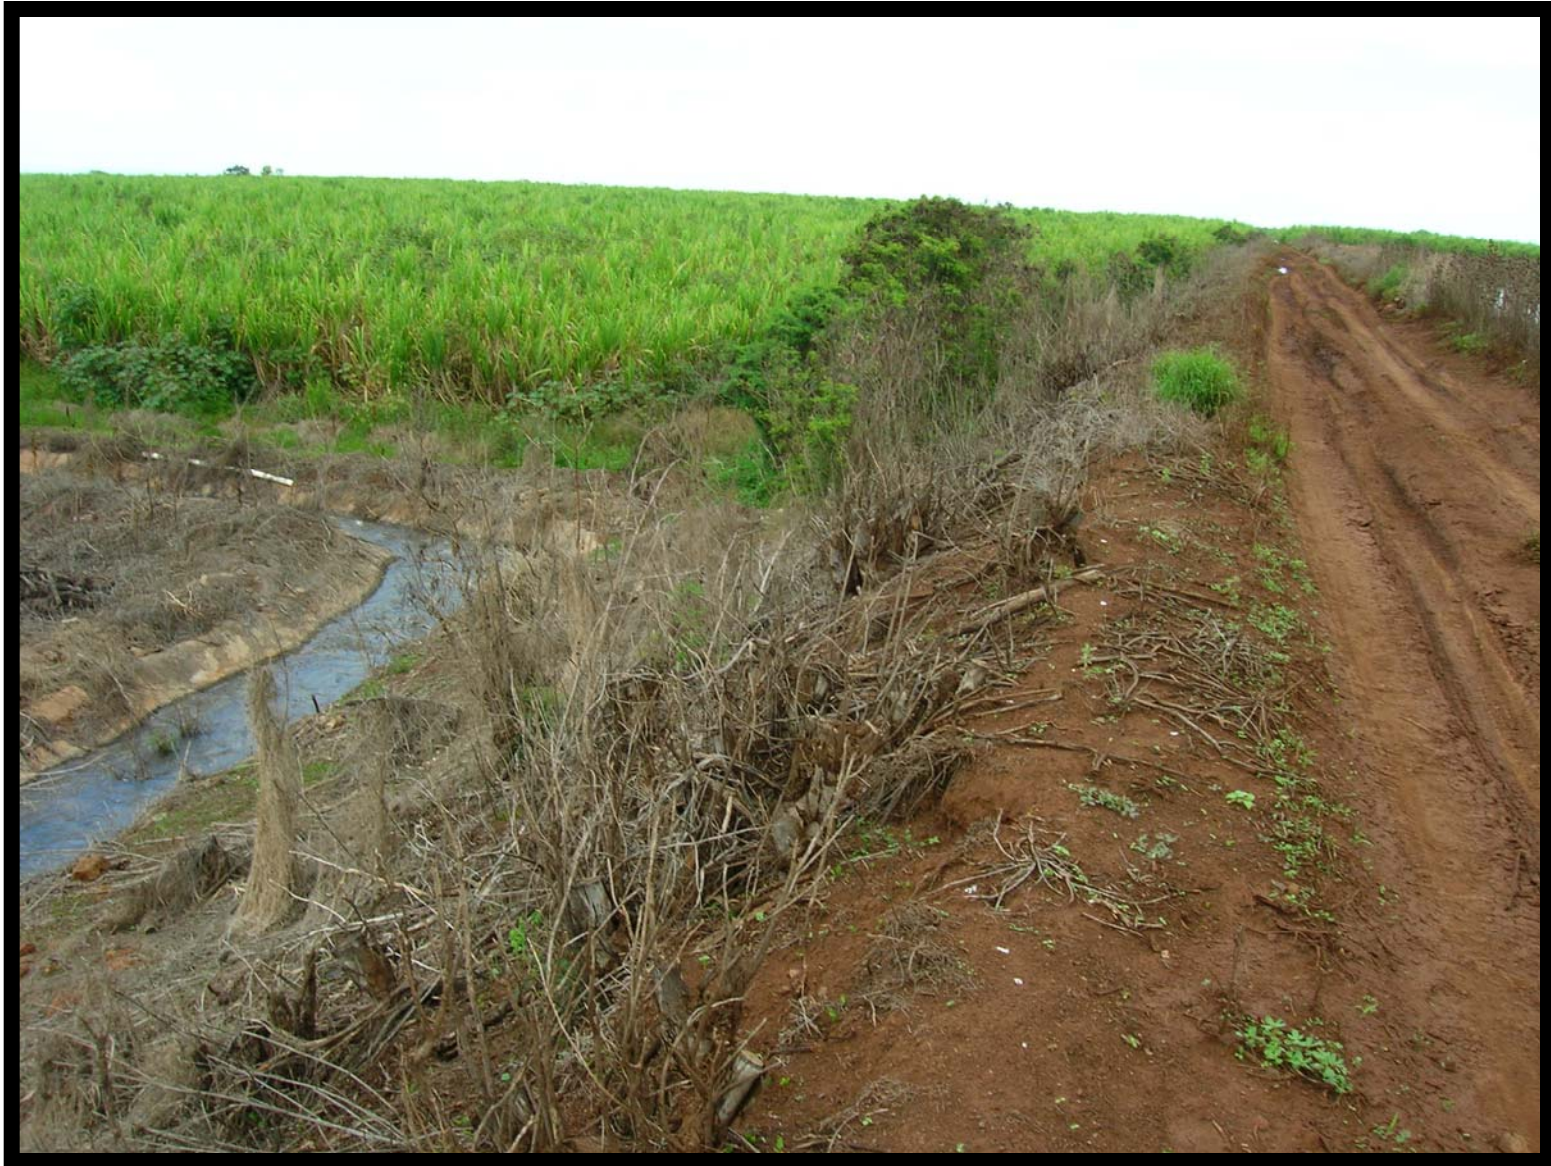
086 downstream slope

The downstream slope was in fair to poor condition and not visible due to heavy vegetation. The slope was very steep, around a 1 on 1.5 slope.

There was no slope protection observed on the downstream slope.

Tall grass, bushes and trees were observed on the downstream slope.

- a. The downstream slope appeared to be in fair to poor condition and requires corrective action.
- b. The down stream slope was not visible due to high grass and bush vegetation. Clear high vegetation and maintain low to enable easy visual inspection.

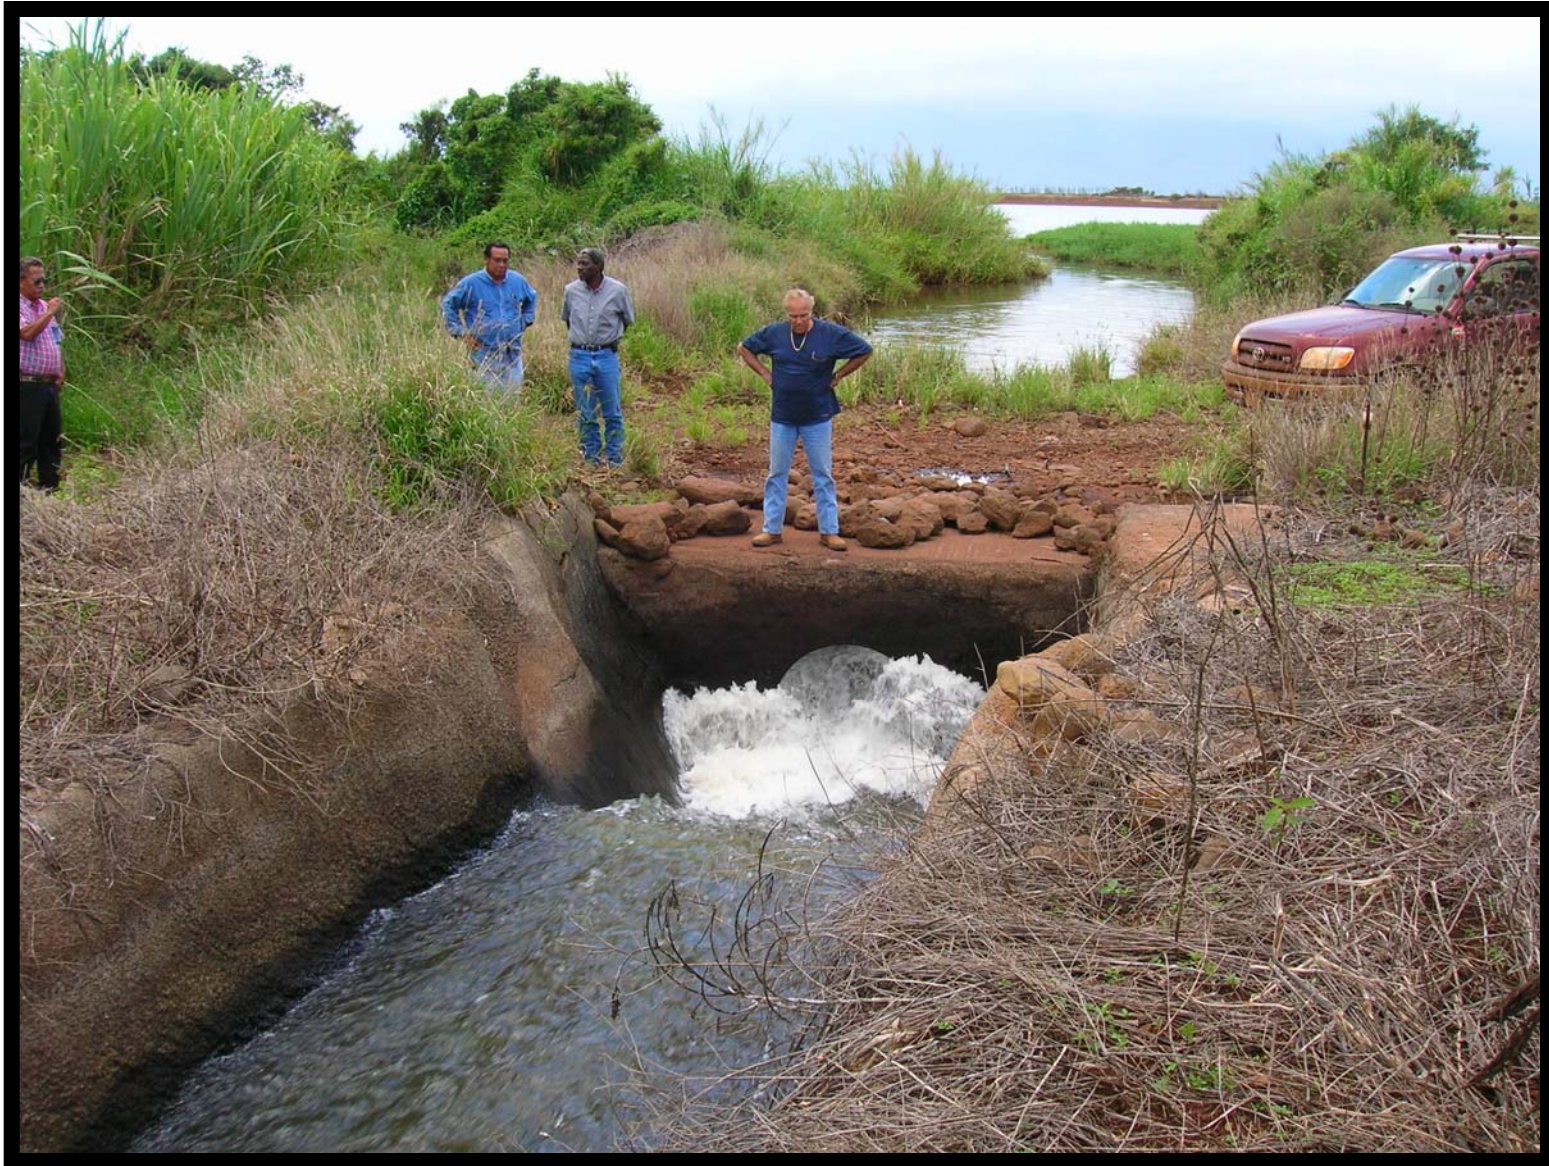
086 inlet

There one inlet feeding the reservoir. This inlet consists of a 3ft wide by 3 ft deep rectangular open channel concrete lined flume. The intake has the ability to be shut off or diverted away from the reservoir during periods of heavy rains. This is done manually with a gate.

- a. The intake works were not tested.
- b. The intake works appeared to be in satisfactory condition, no corrective actions are required at this time.

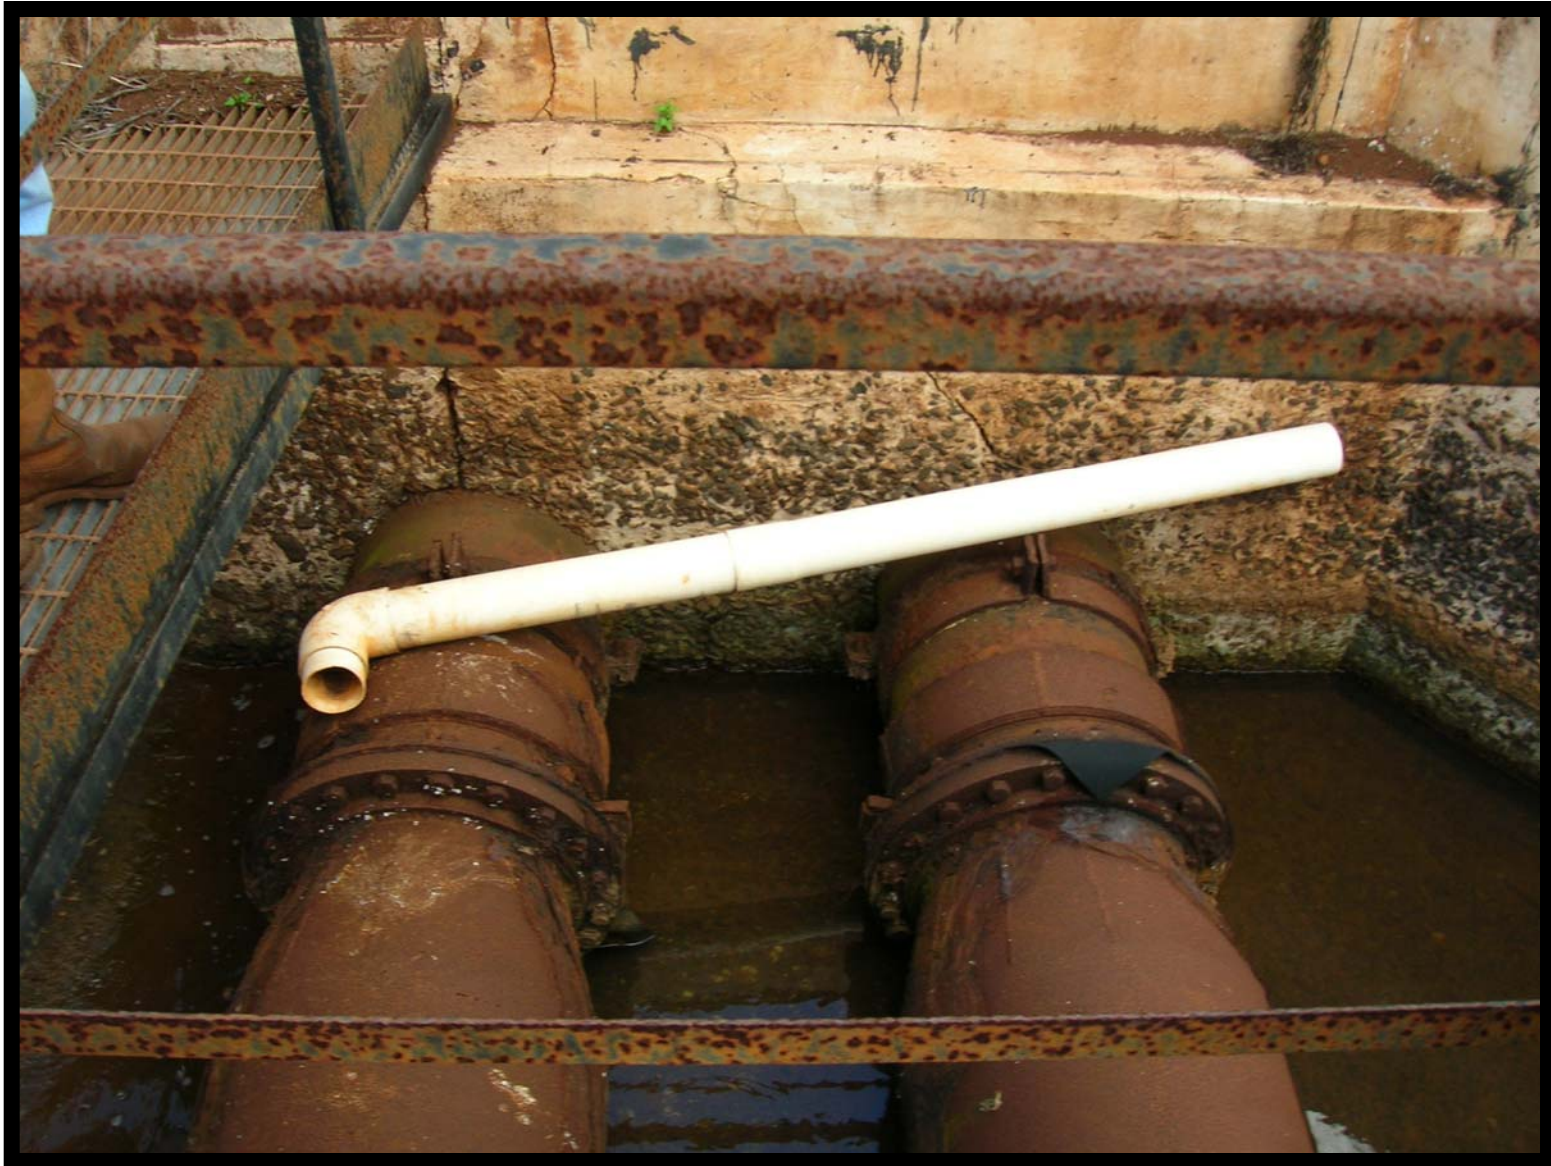
086 outlet

Seepage was not observed flowing near the exit of the outlet works from the dam.

- a. The outlet works were not tested.
- b. The outlet works appeared to be in satisfactory condition, no corrective actions are required at this time.

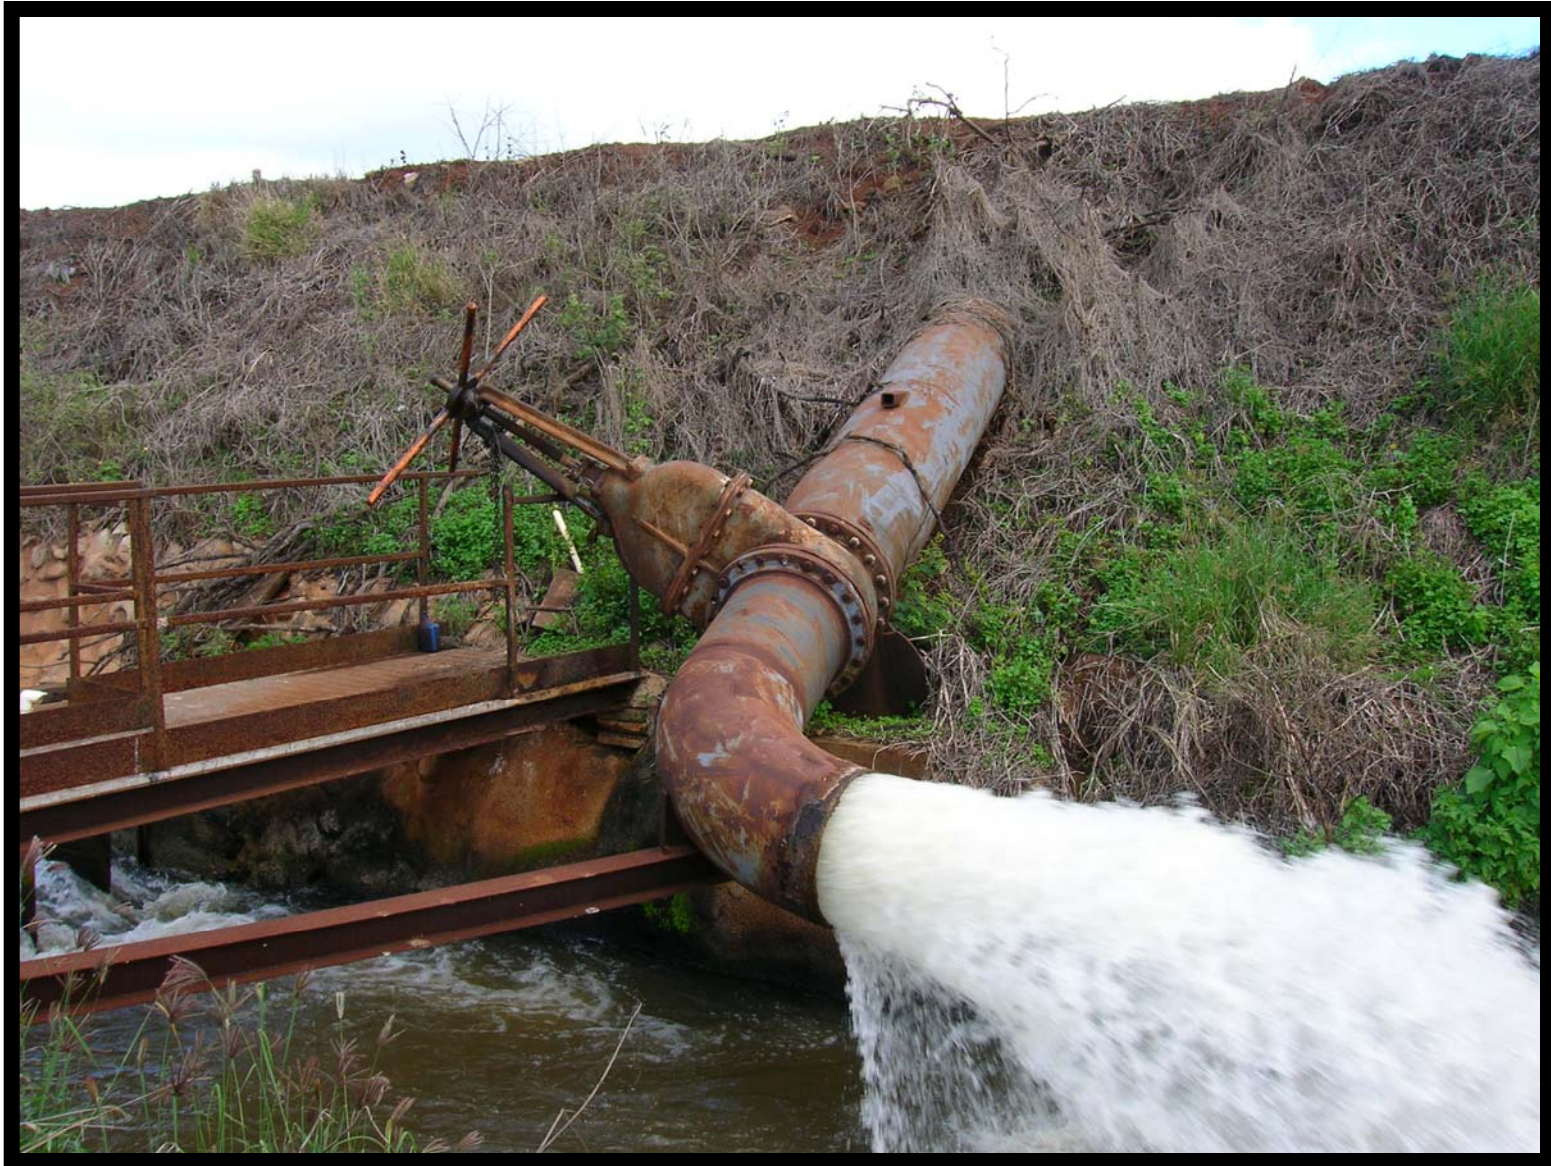
086 outlet 2 - 2nd outlet at higher elevation

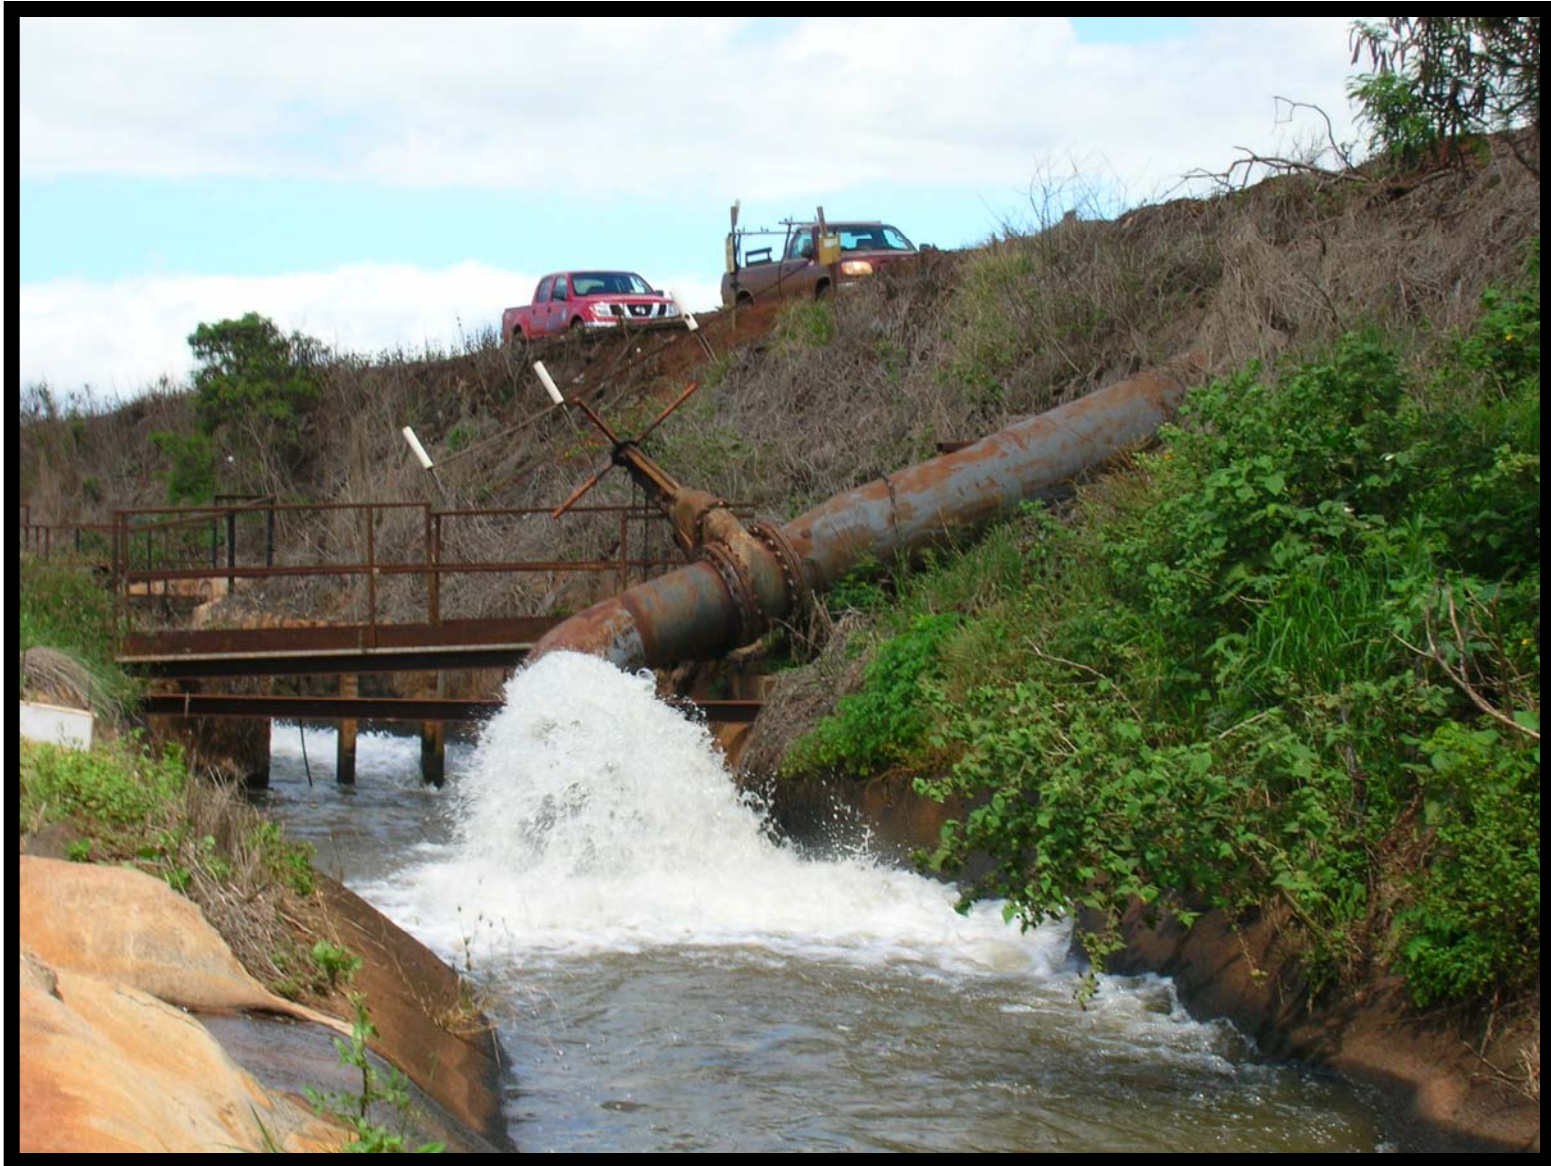
086 outlet 3 - 2nd outlet at higher elevation

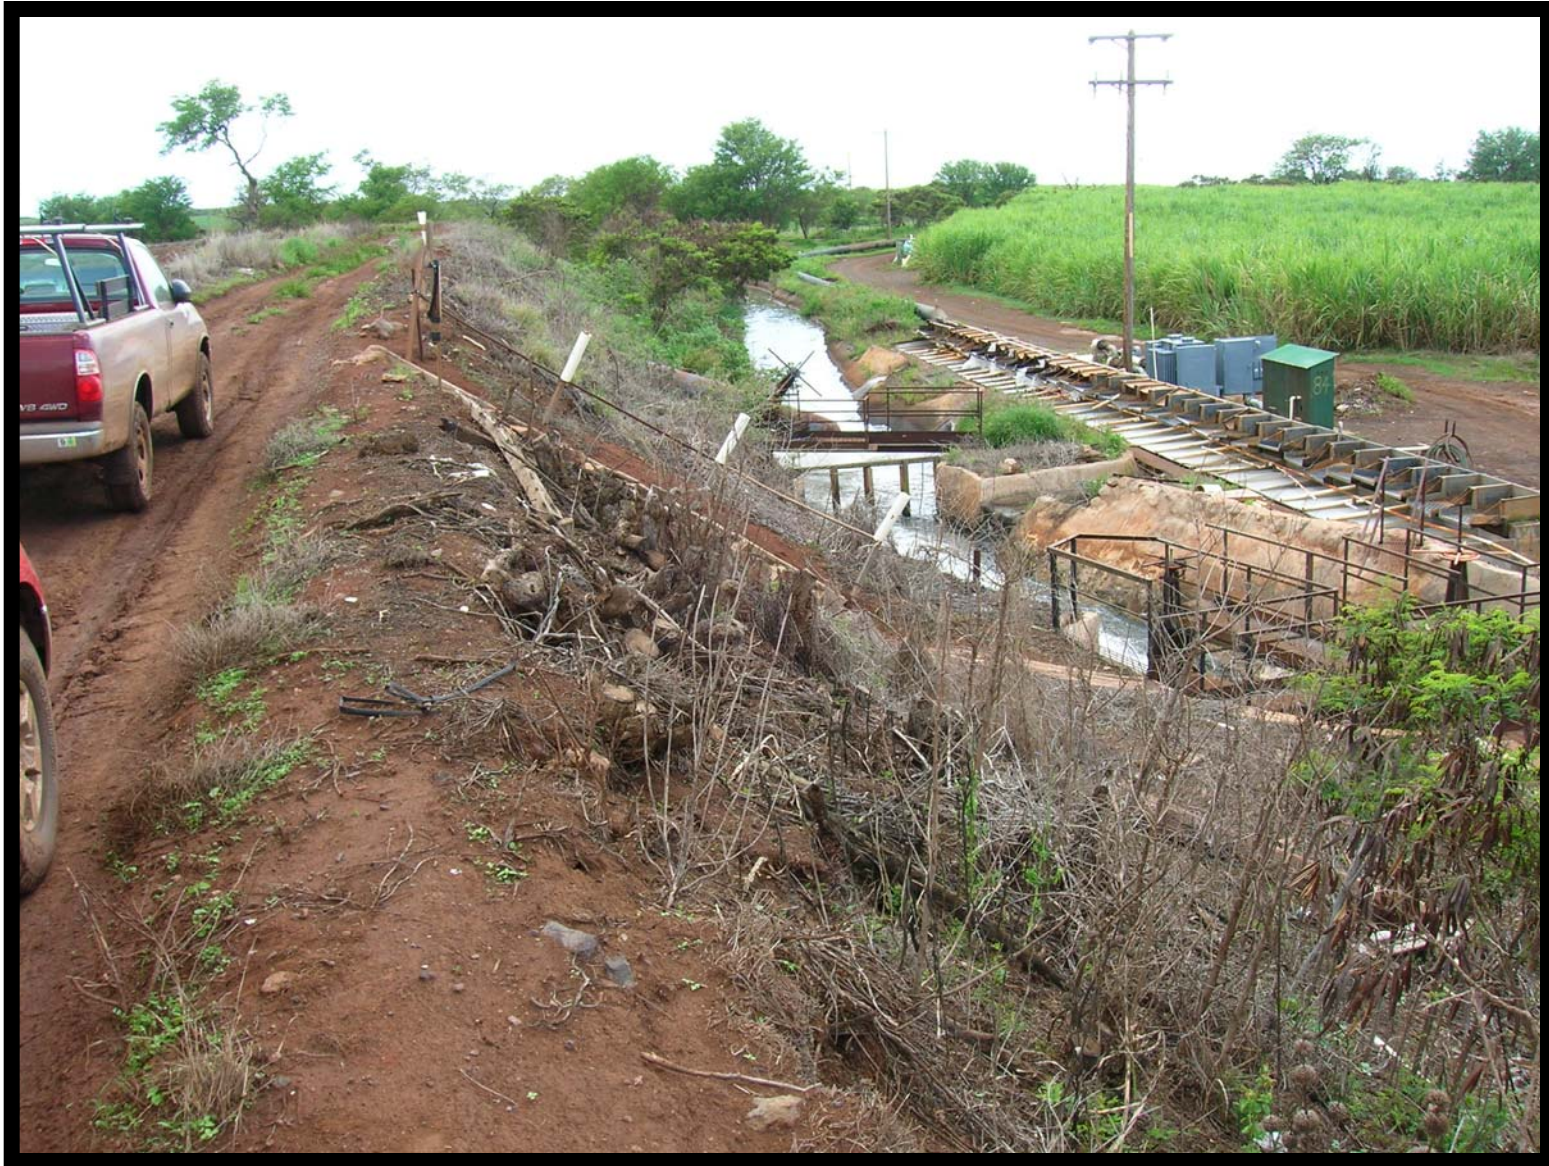
086 outlet channel

- a. The downstream channel was not inspected.
- b. The downstream channel appeared to be in fair to poor condition and requires corrective action.

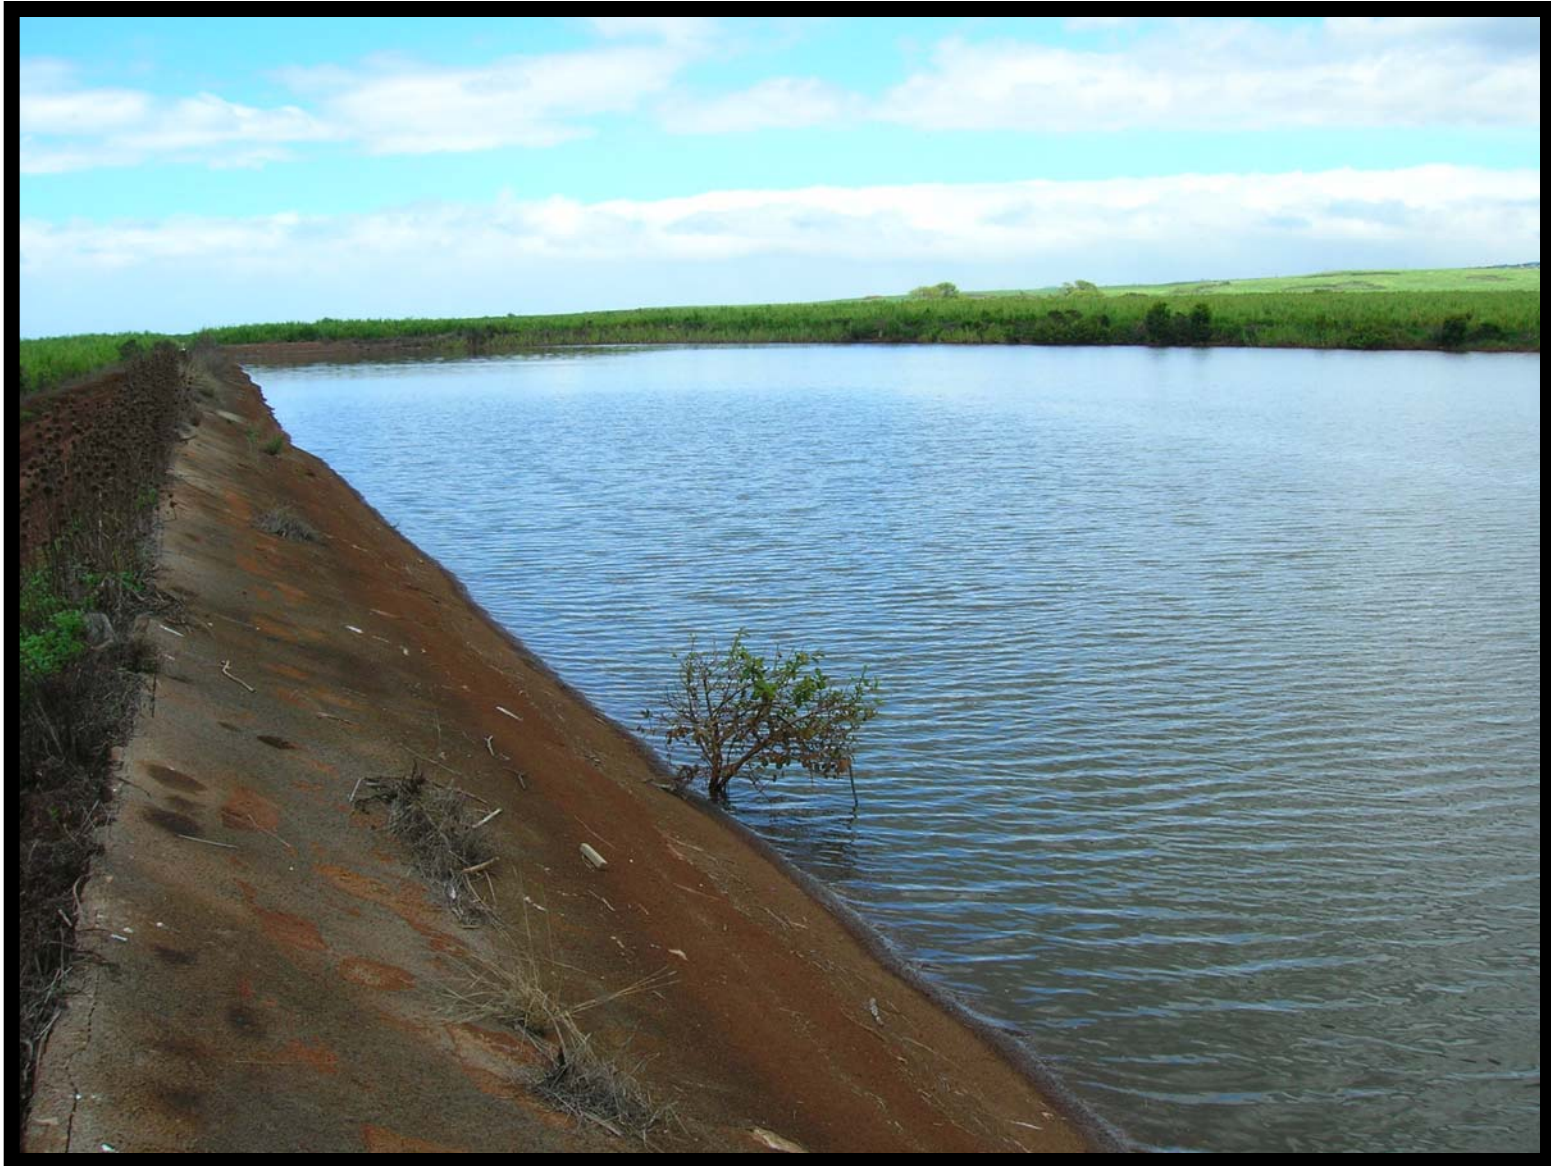
086 reservoir

The reservoir level during the inspection was 14 feet.

Sinkholes or depressions were not observed. Erosion was not observed.

- a. The reservoir appears to be in satisfactory condition, no corrective actions are required at this time.

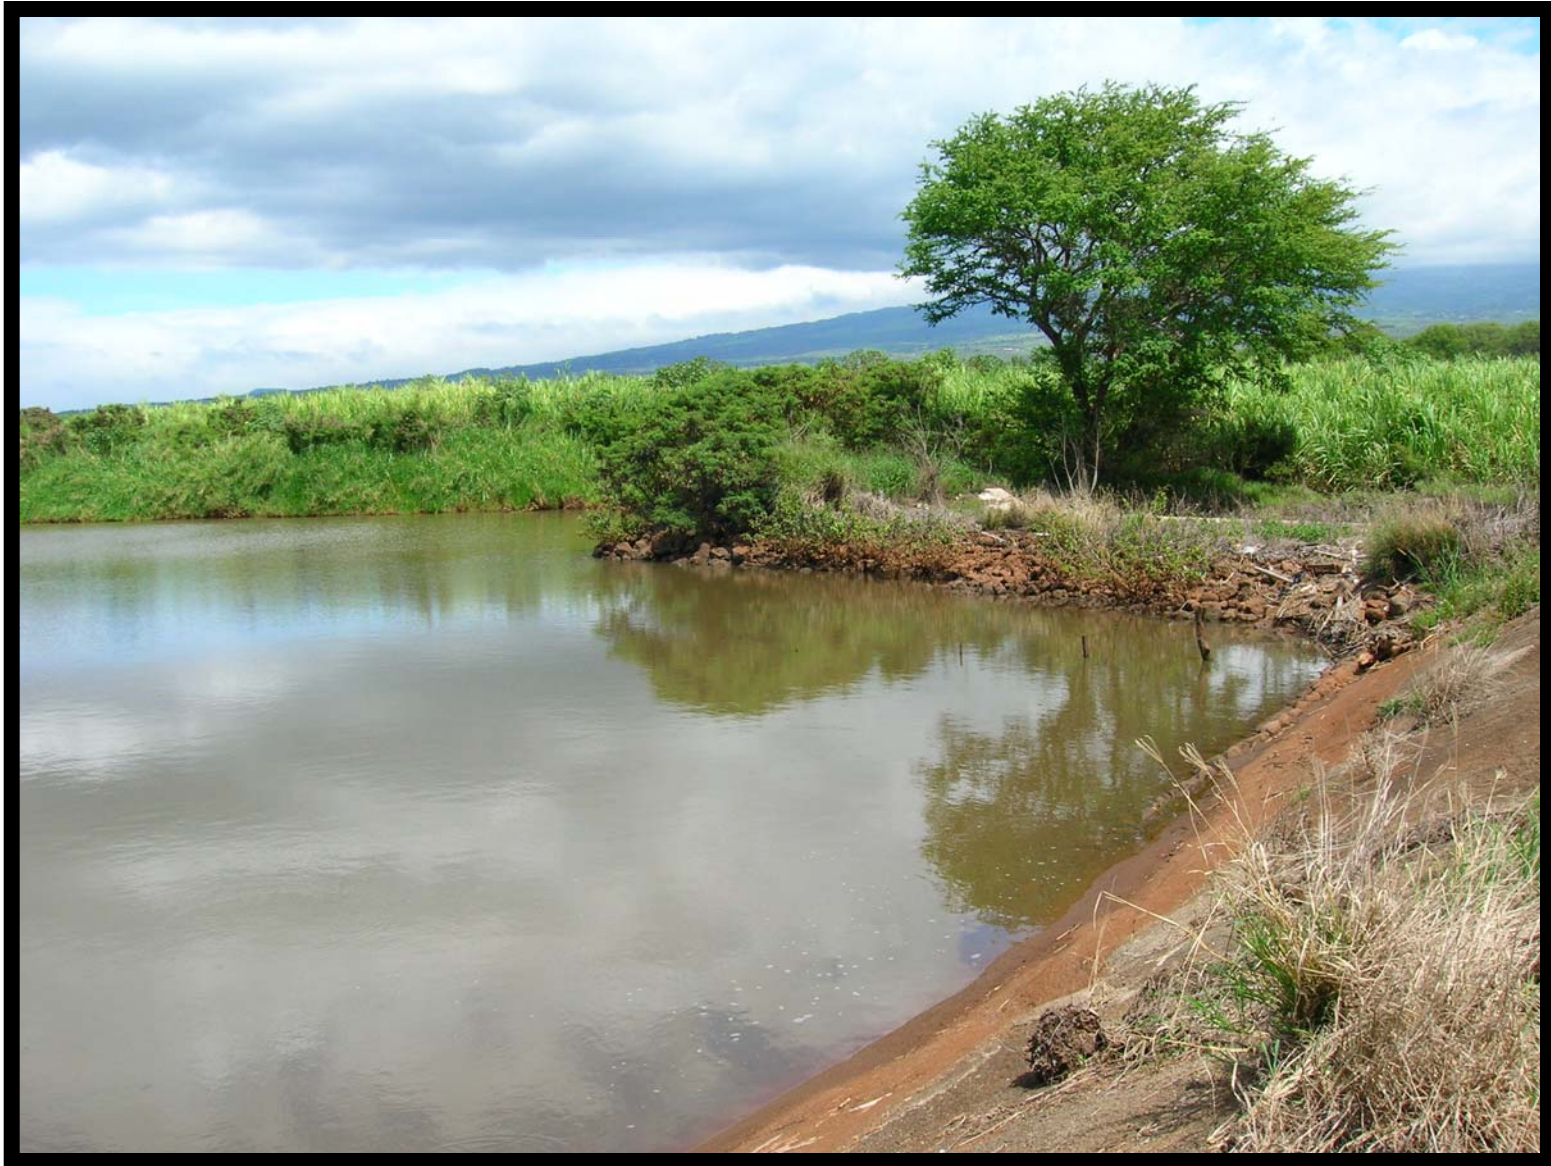
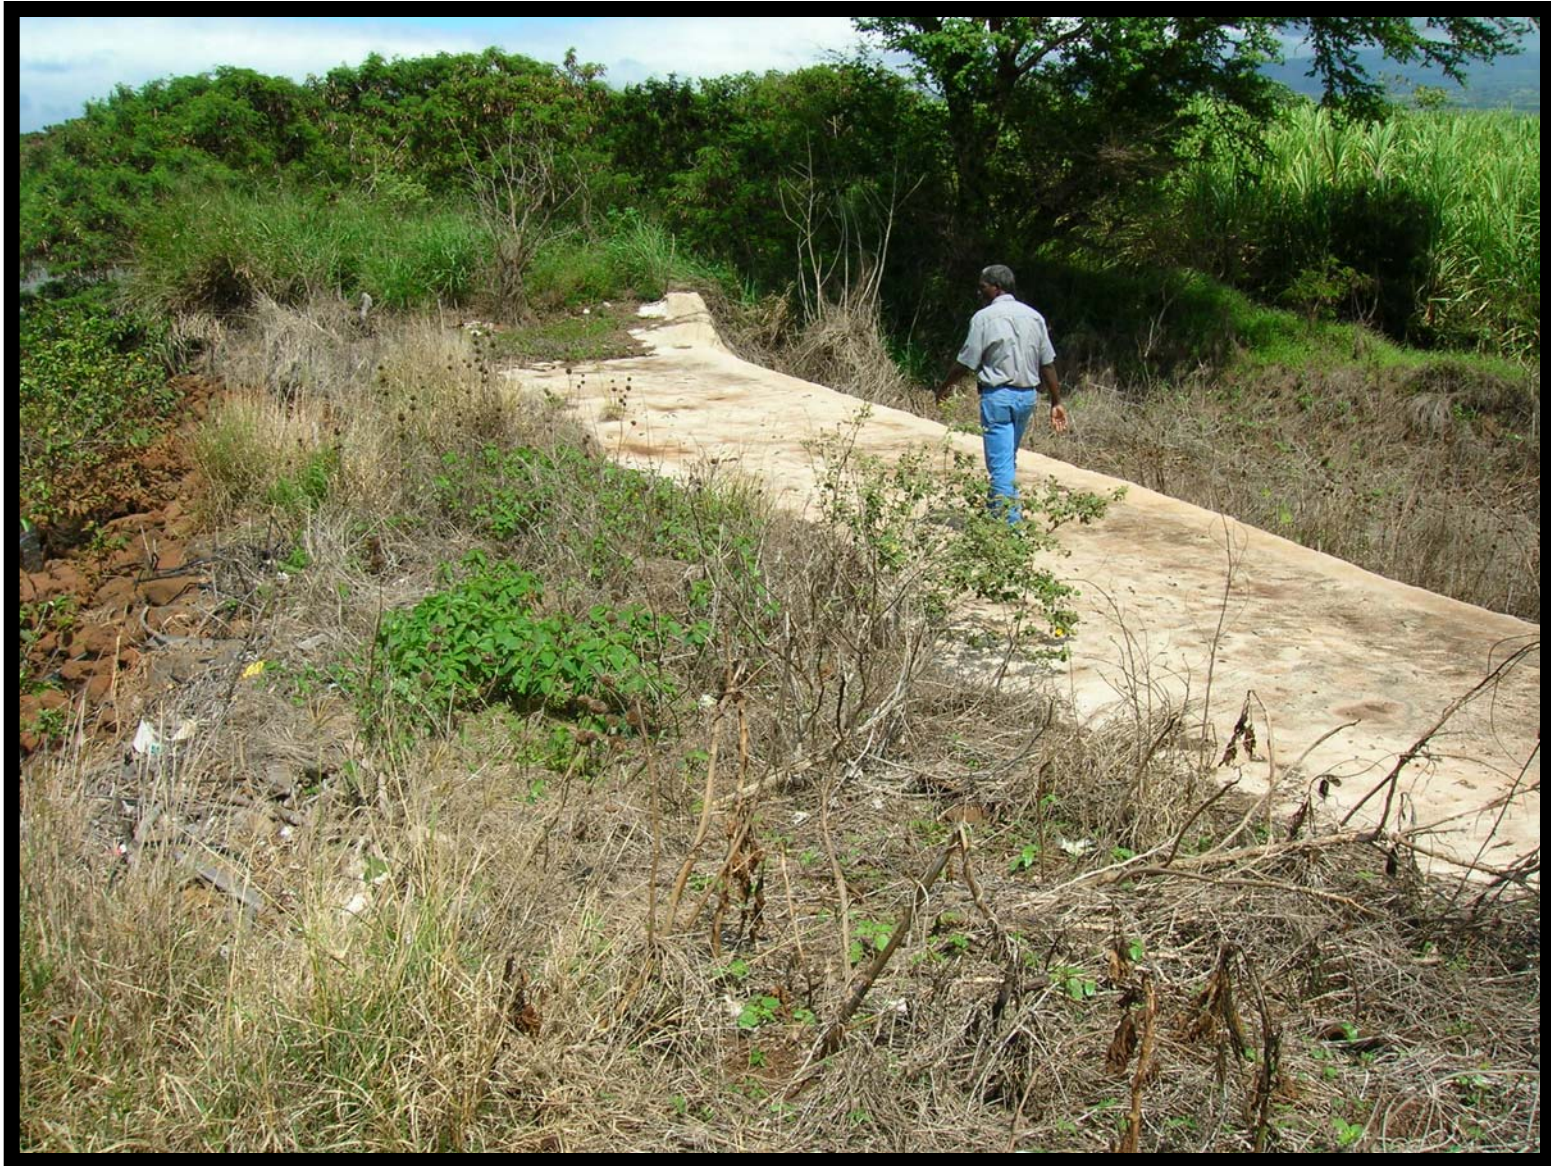
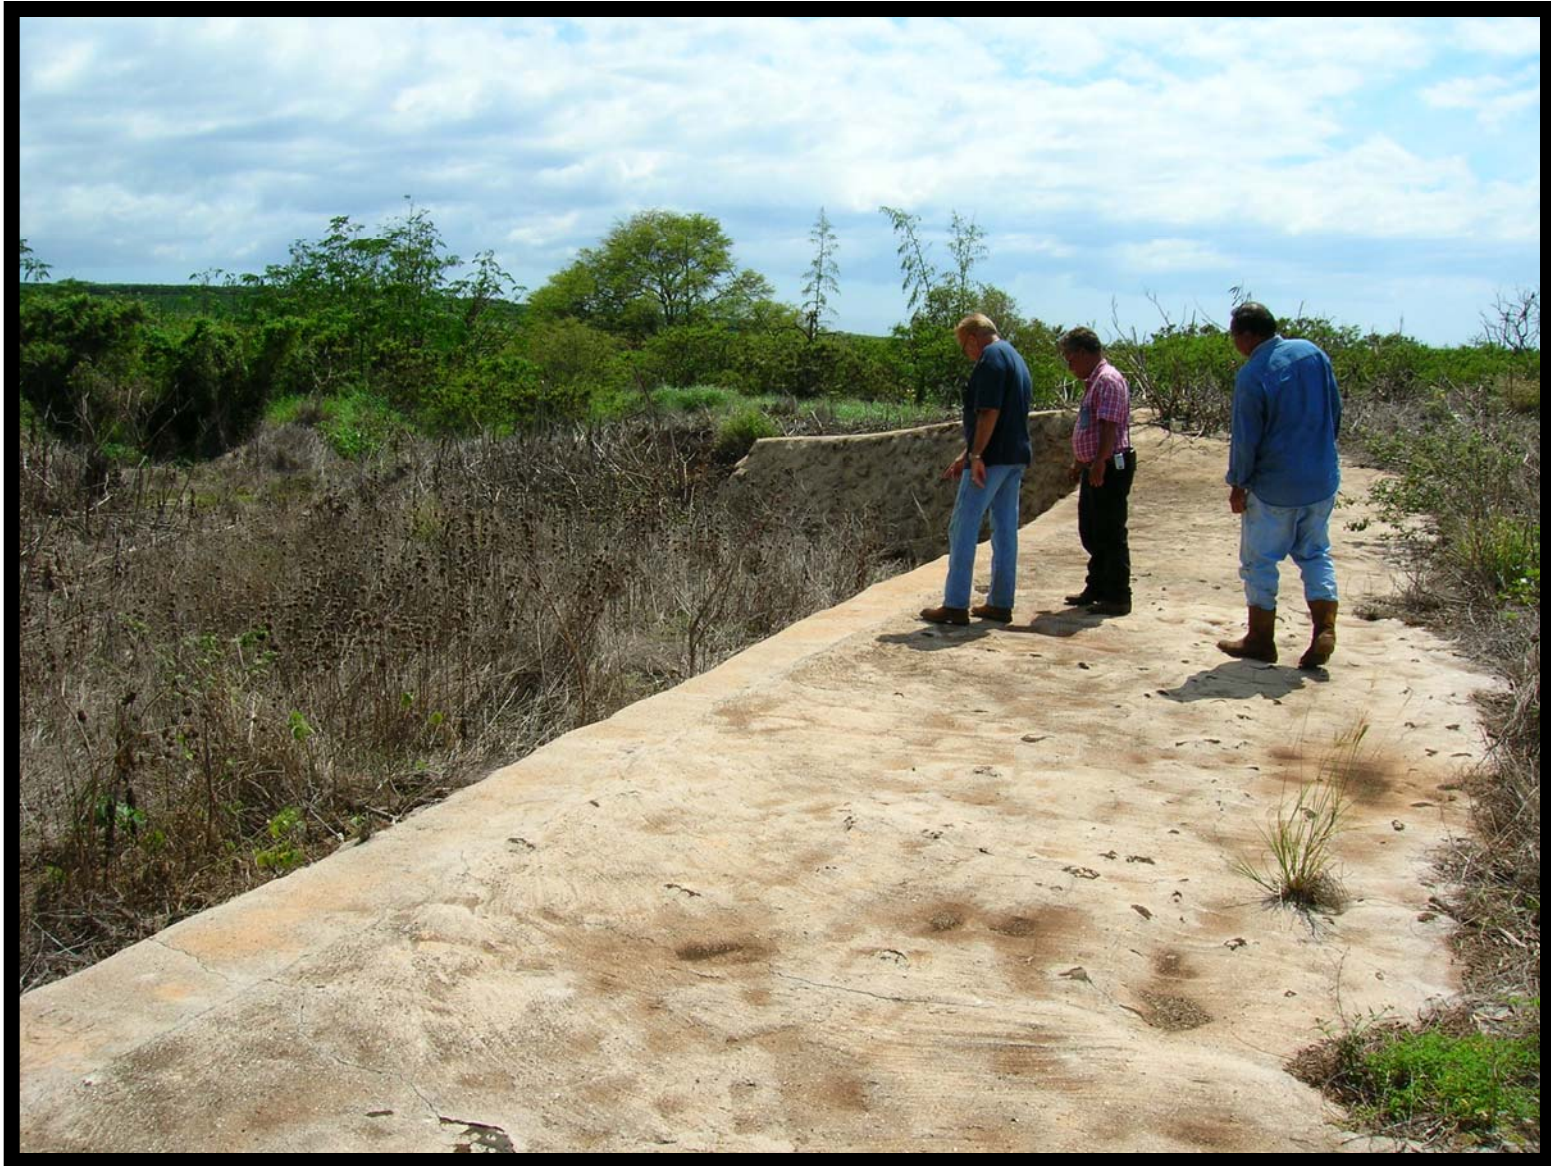
There was no erosion observed near the spillway.

- a. The Spillway appeared to be in fair condition, and requires corrective action.
- b. Unclear if spillway is adequately sized. Spillway should pass the probable maximum flood. Verify spillway capacity and take corrective action as required.
